DEPARTMENT OF TRANSPORTATION**DIVISION OF ENGINEERING SERVICES**

Quality Assurance and Source Inspection

Contract #: 04-0120F4Cty: SF/Ala Rte: 80 PM: 13.2/13.9File #: 69.28**WELDING INSPECTION REPORT****Resident Engineer:**Siegenthaler, Peter**Address:** 333 Burma Road**City:** Oakland, CA 94607**Report No:** WIR-022750**Date Inspected:** 23-Mar-2011**Project Name:** SAS Superstructure**OSM Arrival Time:** 1900**Prime Contractor:** American Bridge/Fluor Enterprises, a JV**OSM Departure Time:** 700**Contractor:** Zhenhua Port Machinery Company, Ltd (ZPMC), Changxing Island **Location:** Shanghai, China**CWI Name:** See below**CWI Present:** Yes No**Inspected CWI report:** Yes No N/A**Rod Oven in Use:** Yes No N/A**Electrode to specification:** Yes No N/A**Weld Procedures Followed:** Yes No N/A**Qualified Welders:** Yes No N/A**Verified Joint Fit-up:** Yes No N/A**Approved Drawings:** Yes No N/A**Approved WPS:** Yes No N/A**Delayed / Cancelled:** Yes No N/A**Bridge No:** 34-0006**Component:** OBG Components**Summary of Items Observed:**

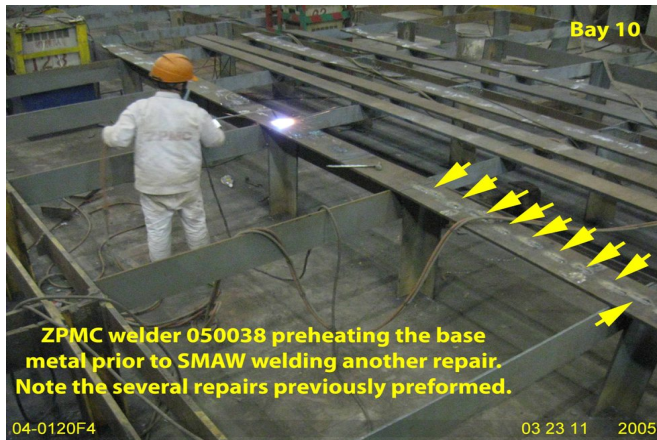
**ZPMC Weld Repair Report B-WR16931
as presented to this QA Inspector**

SMAW repair welding of 31TR1, 31TR2, 31TR3, 36TR1 located on PCMK OBG traveler rail. Welder was identified as 050038. QC was identified as QC1. Assisting QC1 at this location and appearing to be monitoring the welding operation and recording data was QCA1, who was not a CWI. Weld variables recorded by QCA1 appeared to comply with WPS-345-SMAW-1G(1F)-repair as displayed on ZPMC Weld Repair Report B-WR16931 as presented to this QA Inspector and verbally identified by QCA1. See below for photo of page 1 of B-WR16931 and photo of welder 050038 preheating the base metal prior to SMAW welding another repair. Note the several repairs previously preformed.

焊缝缺陷描述: (母材损伤修复)
Description of welding discontinuity:
根据检查报告ZP06-787-J-B-2153回复, 由于维护行车轨道31TR1, 31TR2, 31TR3, 36TR1折弯方向错误, 导致上翼板与腹板下翼板刨开, 导致母材需进行需补深约3mm, 具体位置见下图:
